Pos-I-Tie® Air and Water Penetration Test Brick Veneer to Steel Studs

**Air Infiltration and Water Penetration Testing of a Mock-Up Air Barrier Back-Up Wall Assembly for Compliance with Chapter 13, "Energy Conservation" in the Commonwealth of Massachusetts State Building Code, Effective July 1, 2001.**

The Thompson & Lichtner Company, Inc.

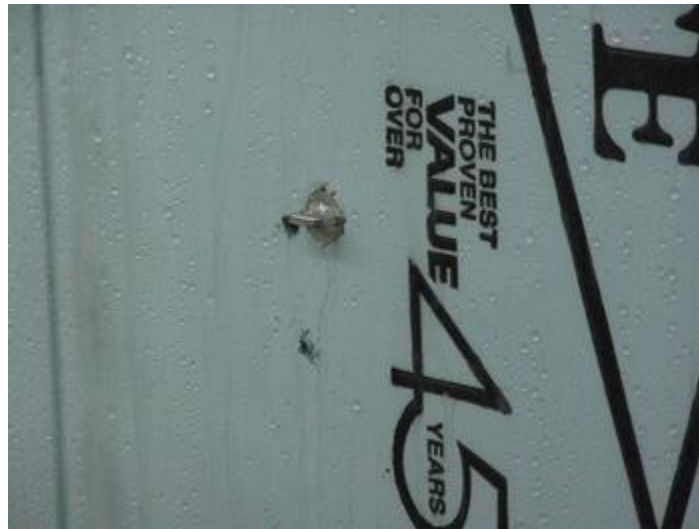
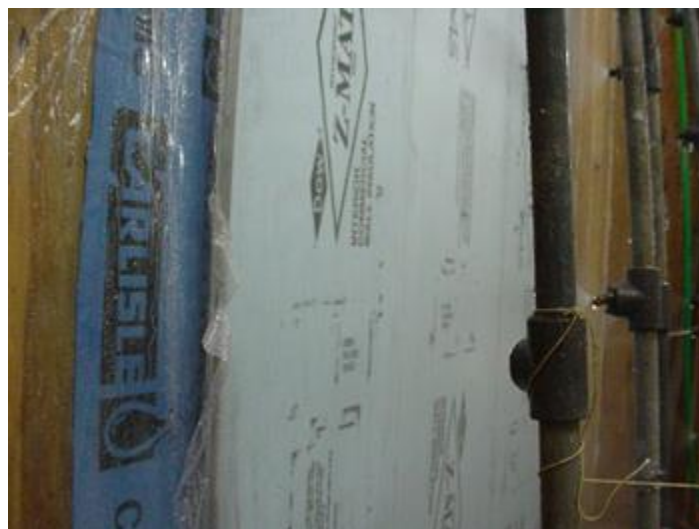
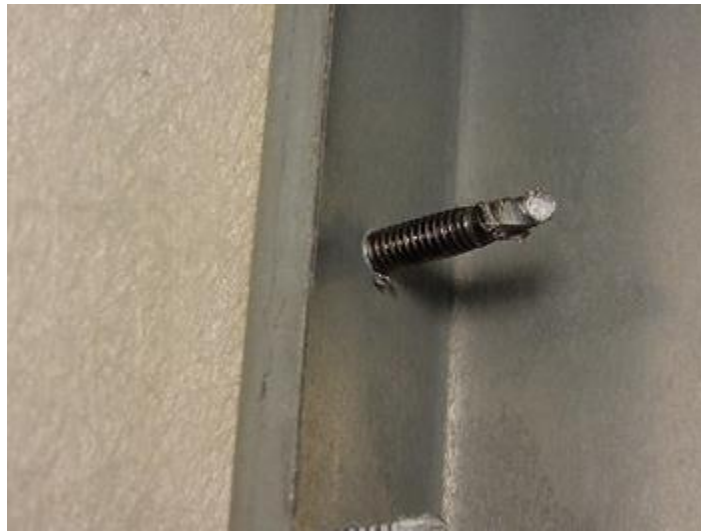
#### Photos From Test

A. Air Barrier Back-Up Wall Assembly - The mock-up air barrier back-up wall assembly was constructed in the laboratory test chamber in the following manner:

1. A back-up wall of 1/2" thick Georgia Pacific Dens Glass was installed over 16 gage 2" x 6" steel studs set at 17" on center. The Dens-Glass sheathing contained one horizontal and one vertical joint.
2. The Dens-Glass back-up wall was primed with two coats of Carlisle 702 primer and allowed to dry. Carlisle 705 cavity wall membrane was installed over the primed Dens-Glass. The wall membrane was pressed into place on the sheathing and at vertical and horizontal joints in the membrane.
3. Dow Z-Mate 2" thick extruded polystyrene insulation boards were placed over the

4. 2-1/2" long Pos-I-Tie® wall tie anchors were screwed into the insulation, air barrier, Dens-Glass, and steel studs of the wall assembly in three horizontal rows spaced at 17" and three vertical columns spaced at 16", for a total of nine wall tie anchors.

The completed mock-up air barrier back-up wall assembly measured 62" wide x 78" high.

Measured Air Leakage	0.0 cft
Calculated Air Infiltration	0.0 cfm per square foot
Allowable Air Infiltration	0.004 cfm per square foot

Water was applied to the exterior side of the mock-up air barrier back-up wall assembly at the standard rate of 5.0 gallons per hour per square foot while a negative chamber pressure of 6.24 was maintained on the interior side of the mock-up. **No leakage was observed on the interior surface of the steel-framed back-up wall assembly during the 15 minute test period.**
